MISCELLANEOUS PAPER S-69-10

EVALUATION OF SURFACING MATERIALS FOR FIRM BASE TACTICAL AIRFIELDS BARE BASE SUPPORT

March 1969

U. S. Army Engineer Waterways Experiment Station CORPS OF ENGINEERS

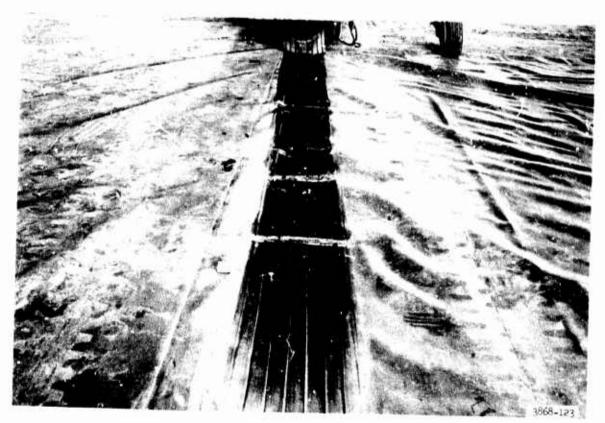
- 22. C-130 loadings on WX18. Initial skid tests were conducted in lane 1 using the C-130 loading. Two skid pulls were conducted, and the WX18 withstood both tests quite well. Only slight superficial abrasions of the WX18 were observed, although there was noticeable tire abrasion (photograph 2).

Photograph 2. Test 1; WX18 after second pull with C-130 loading

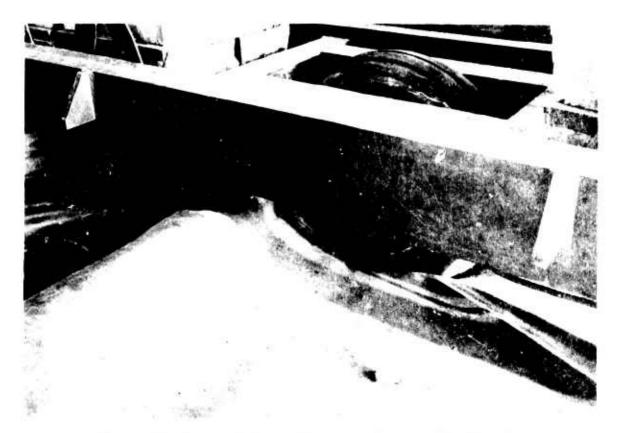
- 23. F-4C loadings on WX18. Skid tests were then conducted in lane 2 using the F-4C loading. About halfway through the first skid, the load wheel sank into the subgrade, immobilizing the vehicle (photograph 3).

- 24. Although the subgrade had been designed for static and rolling F-4C loadings, it was obvious at this time that a higher soil strength would be required to support the additional load generated by a locked-wheel skid. Although there was no damage to the WX18, the skid test was not considered successful. The WX18 was then removed from the test section, and the subgrade soil was further compacted to obtain higher soil strength.

Photograph 3. Test 1; vehicle immobilized during first pull with F-4C loading on WX18 over 24-CBR subgrade

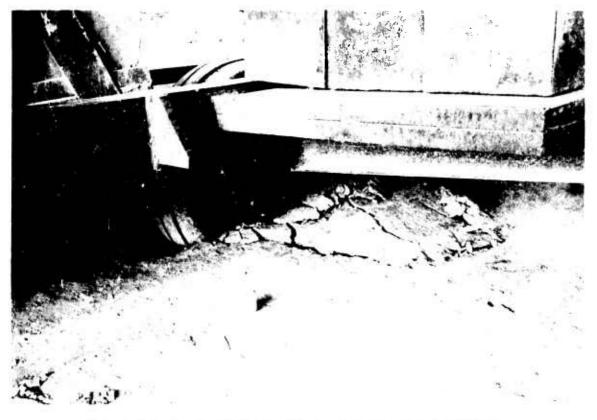
- 26. At this time it was decided to conduct further skid tests on the bare soil surrounding the test section in areas that indicated higher soil strength. The area adjacent to the test section was lean clay soil. The first skid test was conducted in an area in which a cursory check had indicated a surface soil strength of 43 CBR. However, subsequent tests indicated that at 6 in. below the surface, the soil strength was 9 CBR, and the average soil strength was approximately 26 CBR. As the skid pull was begun, the load wheel sank into the soil and became immobilized (photograph 4). A second pull was performed in an area

Photograph 4. Test 1; vehicle immobilized during skid pull with F-4C loading on unsurfaced 26-CBR subgrade

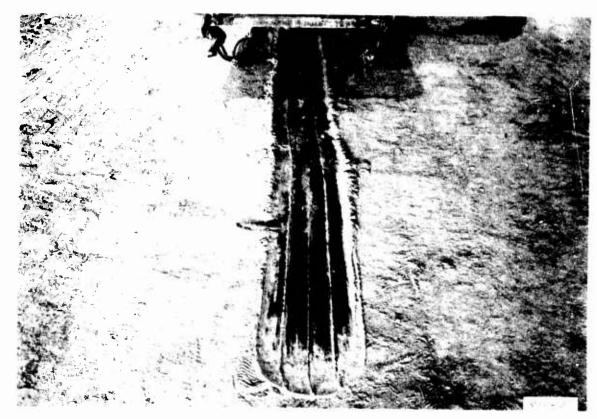
in which a surface strength of 93 CBR was indicated. However, subsequent soil tests indicated the soil strength at 6 in. below the surface to be 66 CBR, and the average strength was 80 CBR. The test vehicle was pulled approximately 15 ft, and no sinkage or rutting was observed (photograph 5).

Photograph 5. Test 1; unsurfaced 80-CBR area after pull with F-4C loading

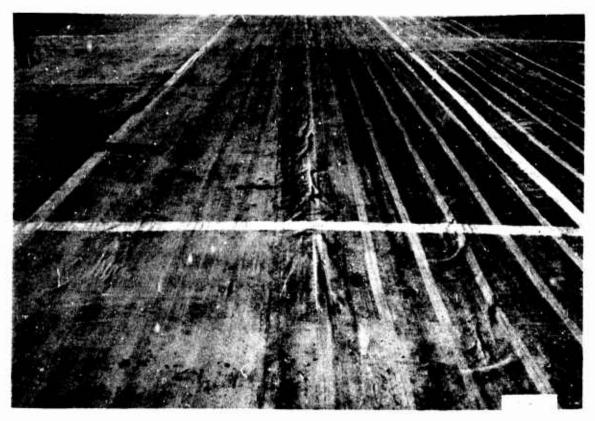
Photograph 6. Test 2: WX18 membrane prior to skid tests

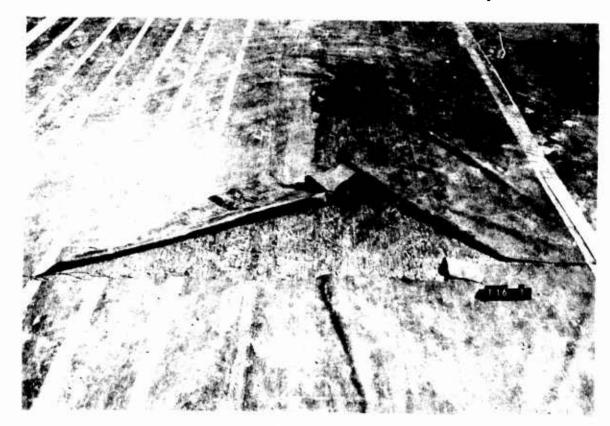
- 32. All tests were conducted with the F-4C loading only. Results are presented in the following paragraphs.
- 33. Skid tests on WX18. Two locked wheel skid pulls were made initially on the WX18 membrane. The skid tests caused only slight abrasion of the WX18, although there was noticeable wear of the load tire (photograph 9).

- 34. Skid test on T16. One skid pull tore the T16 membrane severely, exposing the underlying base soil (photograph 10).
- 35. Skill tests on DBST over T1. Two skid pulls were conducted on the DBST over T1. Both the DBST and the T1 failed on both occasions, exposing the underlying base soil (photograph 11).

Photograph 9. Test 2; WX18 after second pull with F-4C loading

Photograph 10. Test 2; T16 after one pull with F-4C loading

Photograph 11. Test 2; DBST over T1 after pull with F-4C loading

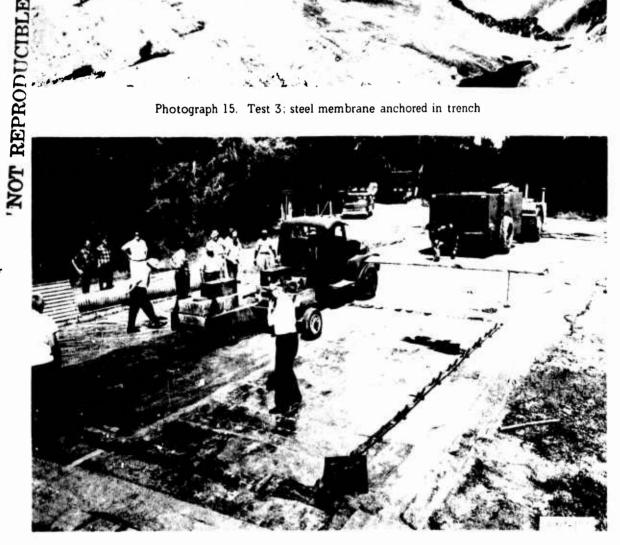
Photograph 15. Test 3; steel membrane anchored in trench

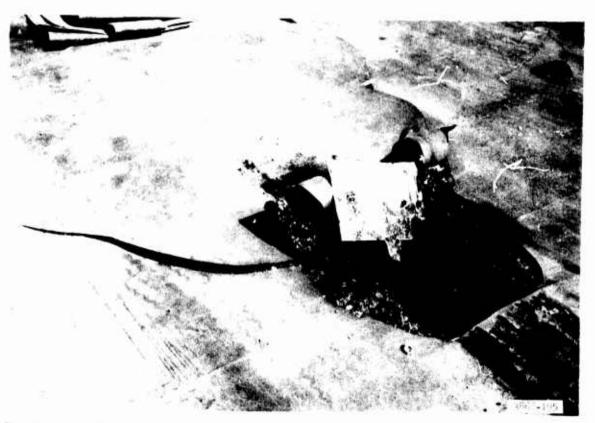
- 43. Wet steel membrane. Two skid tests were conducted on the membrane in a wet condition. The first pull produced no damage to the membrane, although there was a bow wave buildup of membrane in front of the load tire. On the second pull, a slight tear developed near a lapped joint, as can be seen in photograph 20.

Photograph 18. Test 3; close-up of steel membrane after second dry-surface skid test with F-4C loading

Photograph 19. Test 3; general view of steel membrane after second dry-surface skid test with F-4C loading

Photograph 20. Test 3; steel membrane after second wet-surface skid with F-4C loading

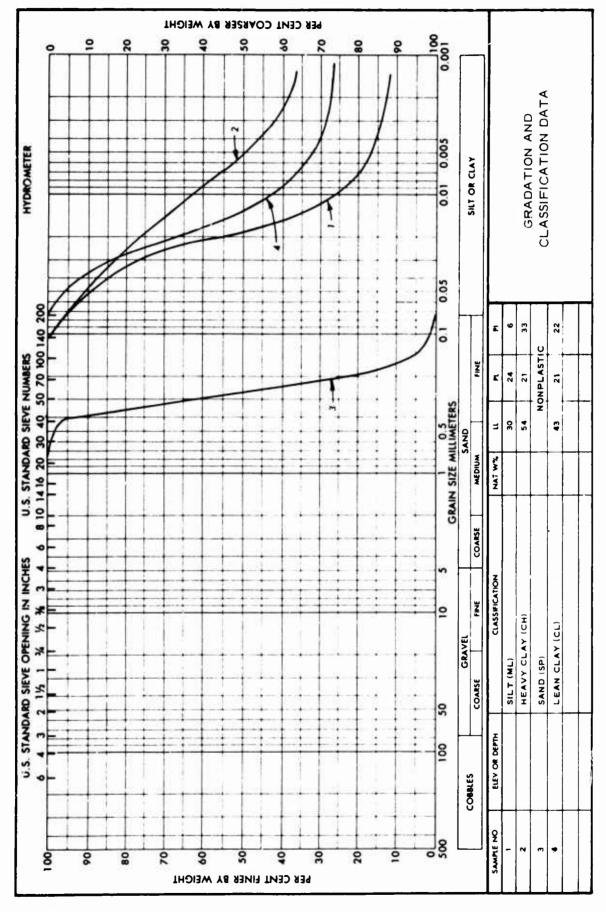
PLATE 2

- 30. Items 4-6 had a common and continuous base course approximately 18 in thick, which was constructed of highly compacted heavy clay (CH). Classification data are shown in plate 2. The average strength of the top 15 in. of soil in the heavy clay base was approximately 44 CBR. Below the base course was a specially constructed subgrade of a loose dry sand (SP). Classification data are shown in plate 2.

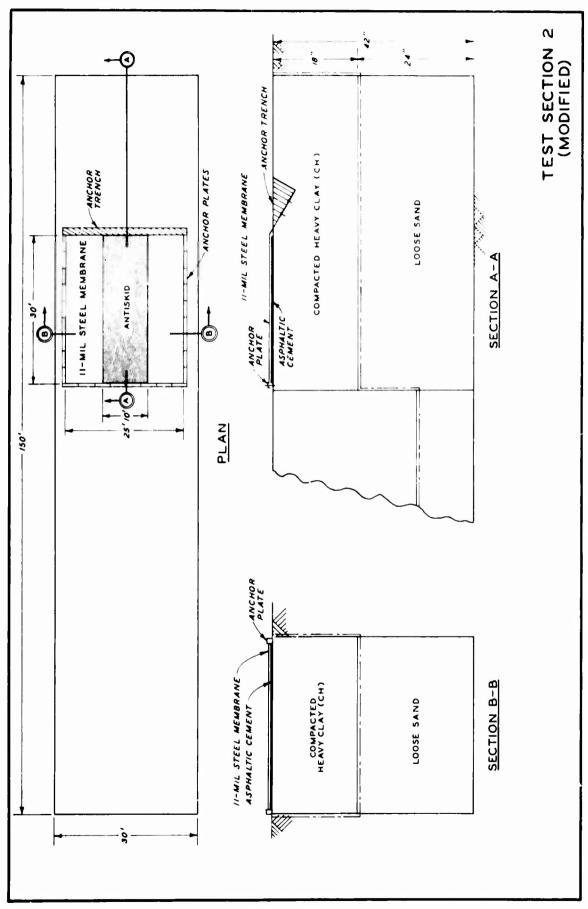
PLATE 4

40. Test 3 was performed on the same site as test 2. A plan and profile of the test section are shown in plate 4. For test 3, the membranes that had been on the section for use in test 2 were removed, and 11-mil steel membrane was placed on the heavy clay base. The membrane was approximately 30 ft long and 25 ft wide. Prior to placement of the membrane, the bare soil was treated with 85-100 penetration asphaltic cement, which was distributed at the rate of approximately 0.5 gal per sq yd. The asphaltic cement was used to provide a bonding agent between the soil and the membrane. The membrane was anchored at one end in a trench cut laterally across the test section (photograph 15). Steel plates were bolted to the membrane, and anchor spikes were driven through the plates into the ground (photograph 15), thus securely pinning the membrane in the trench. After the trench had been backfilled, the membrane was anchored by means of steel plates and pins on the surface around the remaining perimeter. The membrane
